2008 Annual Inspection for the Gunnison, Colorado, UMTRCA Title I Disposal Site

Summary

The Gunnison, Colorado, Disposal Site, inspected on June 3, 2008, is in excellent condition. Fence strands were broken in several locations due to significant snow accumulations during the past winter. Several perimeter signs had substantial bullet hole damage and one sign was missing. The fence was repaired, and the damaged and missing signs were replaced on June 19, 2008. Six riprap test areas on the cell apron and diversion ditches were visually inspected; no apparent rock degradation was noted when compared to photos taken in 2007. Snowmelt runoff resulted in minor erosion near the southeast corner of the site. No cause for a follow-up inspection was identified.

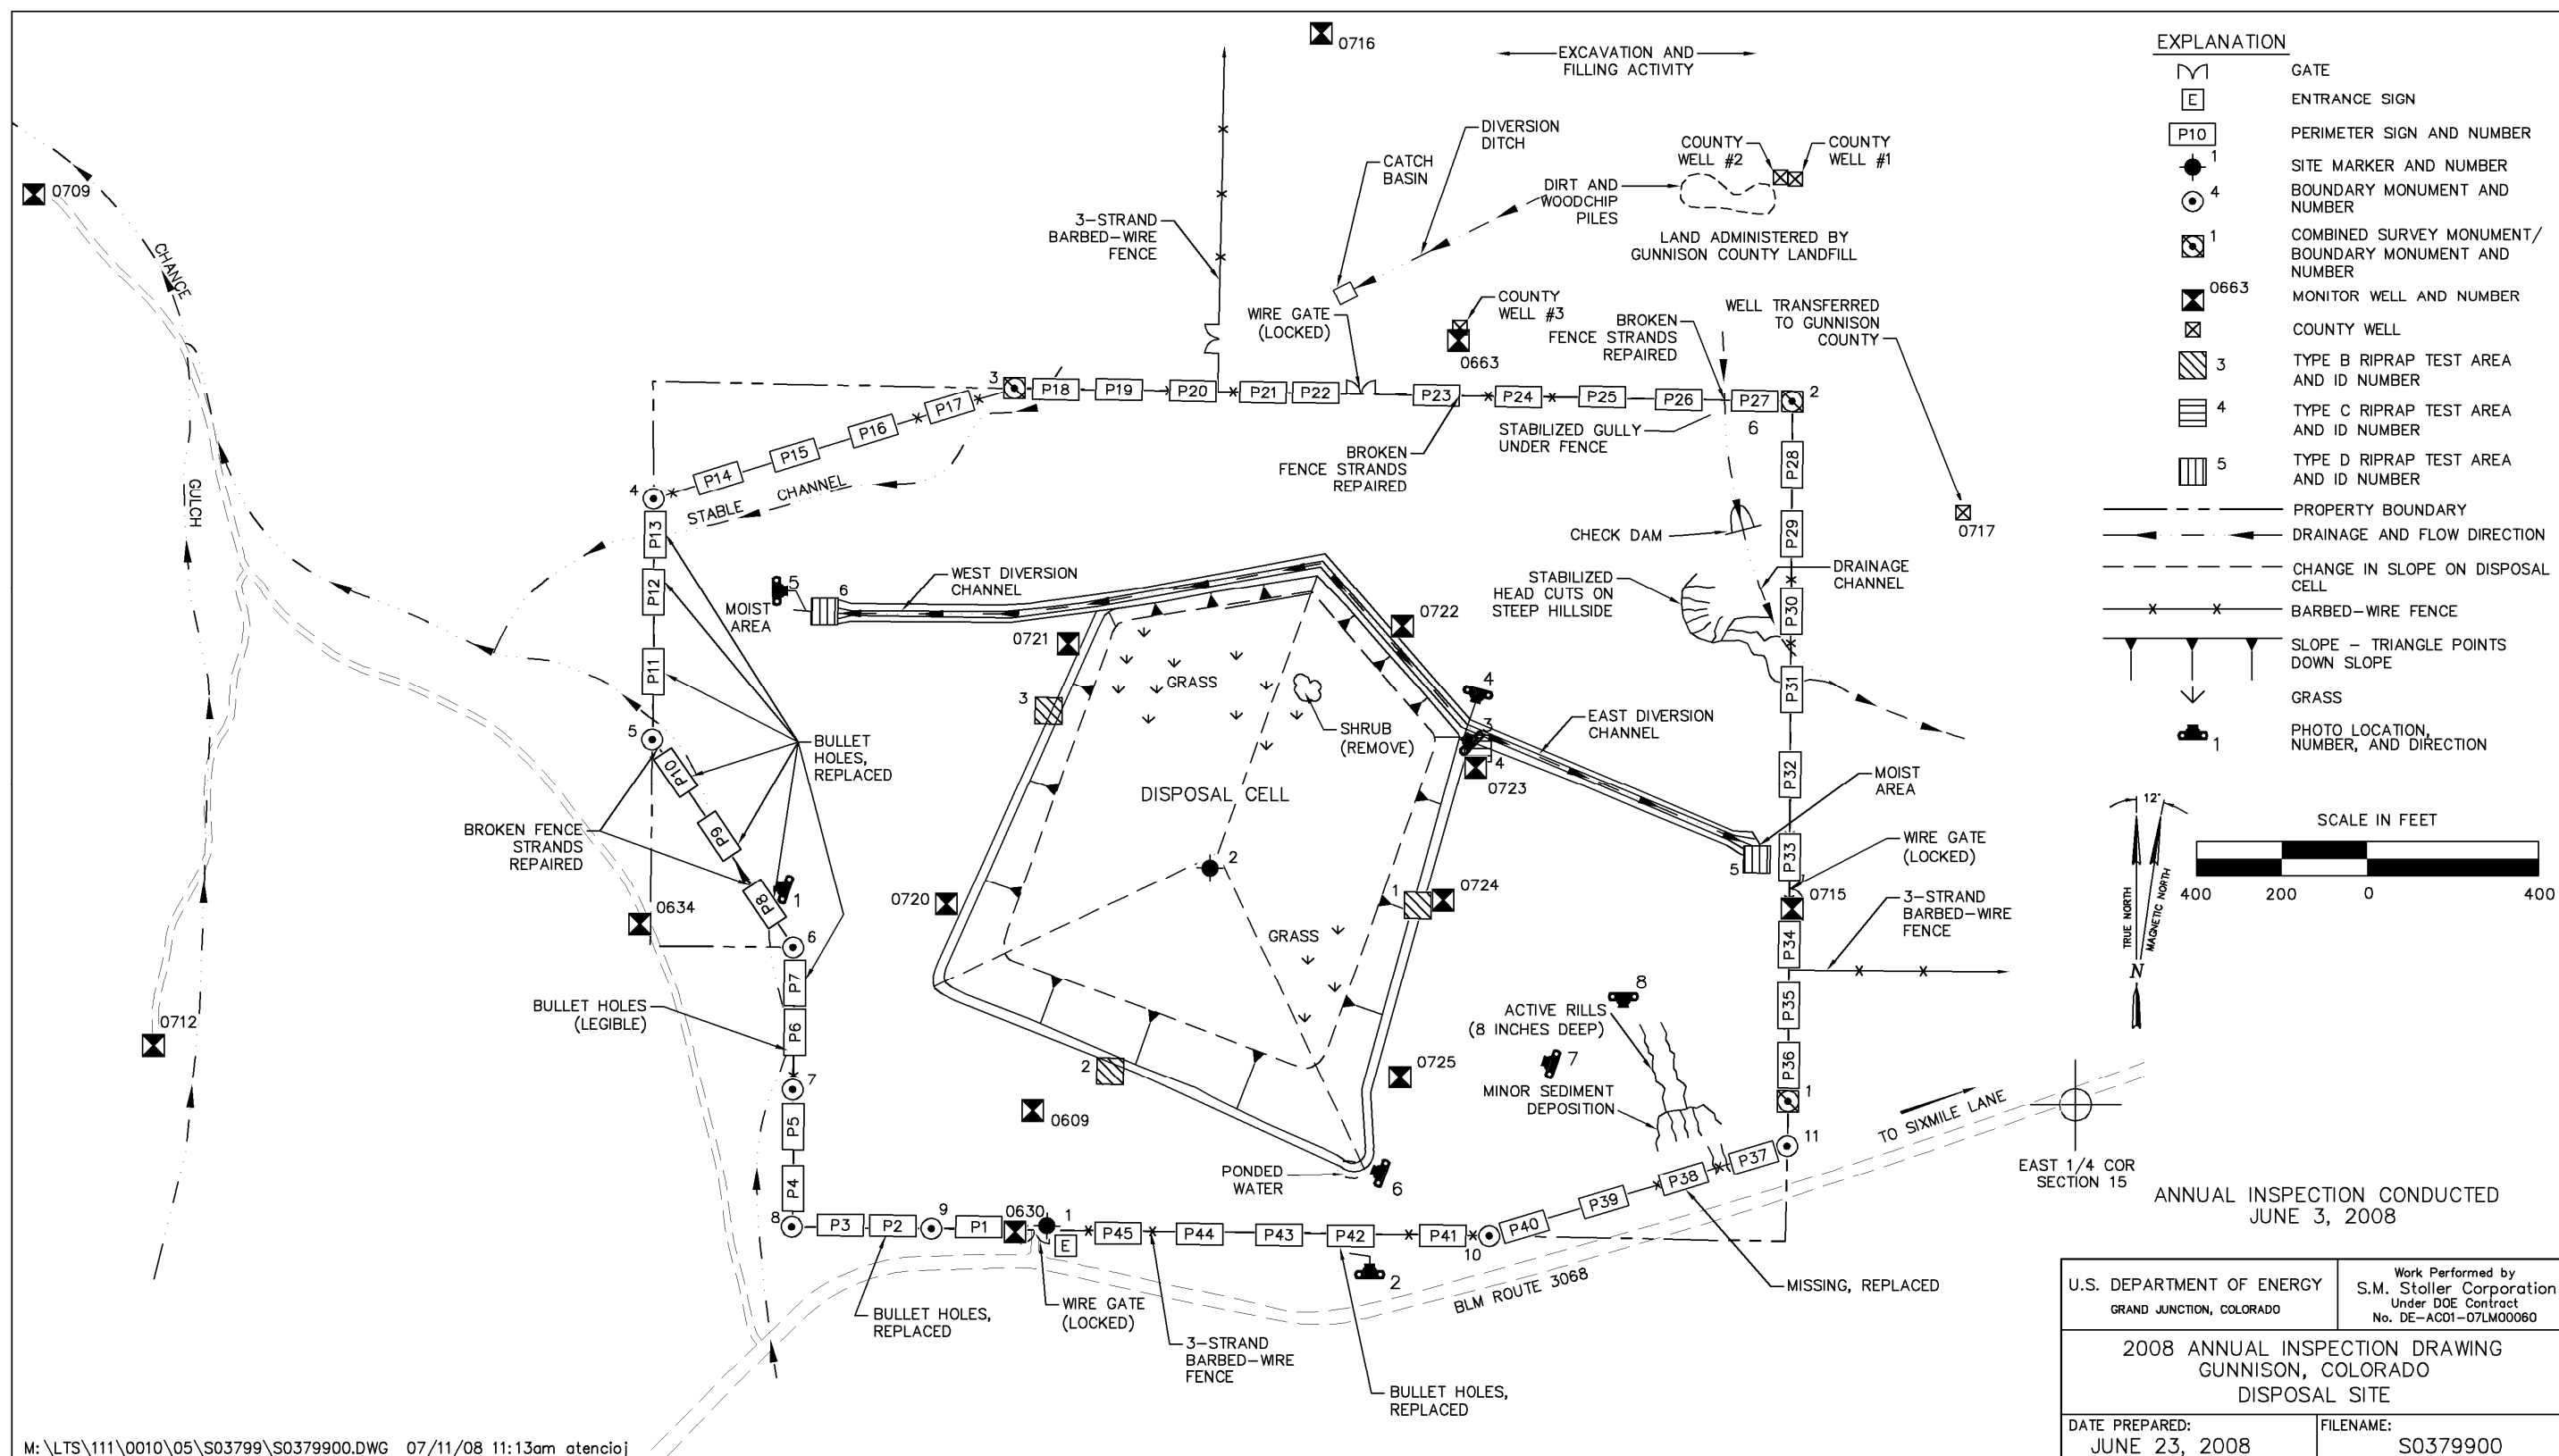
Several locations in areas of steep topography had been susceptible to erosion in the past. Snowmelt runoff caused minor rill erosion and sediment deposition at a location near the southeast corner of the site (PL-8). No erosion control is necessary at this time and the area is expected to stabilize; however, this area will continue to be monitored. All other areas were stable with no evidence of new erosion.

GUN 5/2008. PL-8. Erosion area near the southeast corner of the site.
